UNITED STATES DISTRICT COURT
DISTRICT OF MARYLAND

UNITED STATES OF AMERICA v. EFPLOIA SHIPPING CO., S.A.

UNITED STATES OF AMERICA v. AQUAROSA SHIPPING, A/S

Attachment B
GOVERNMENT'S
MOTION FOR WHISTLEBLOWER AWARD

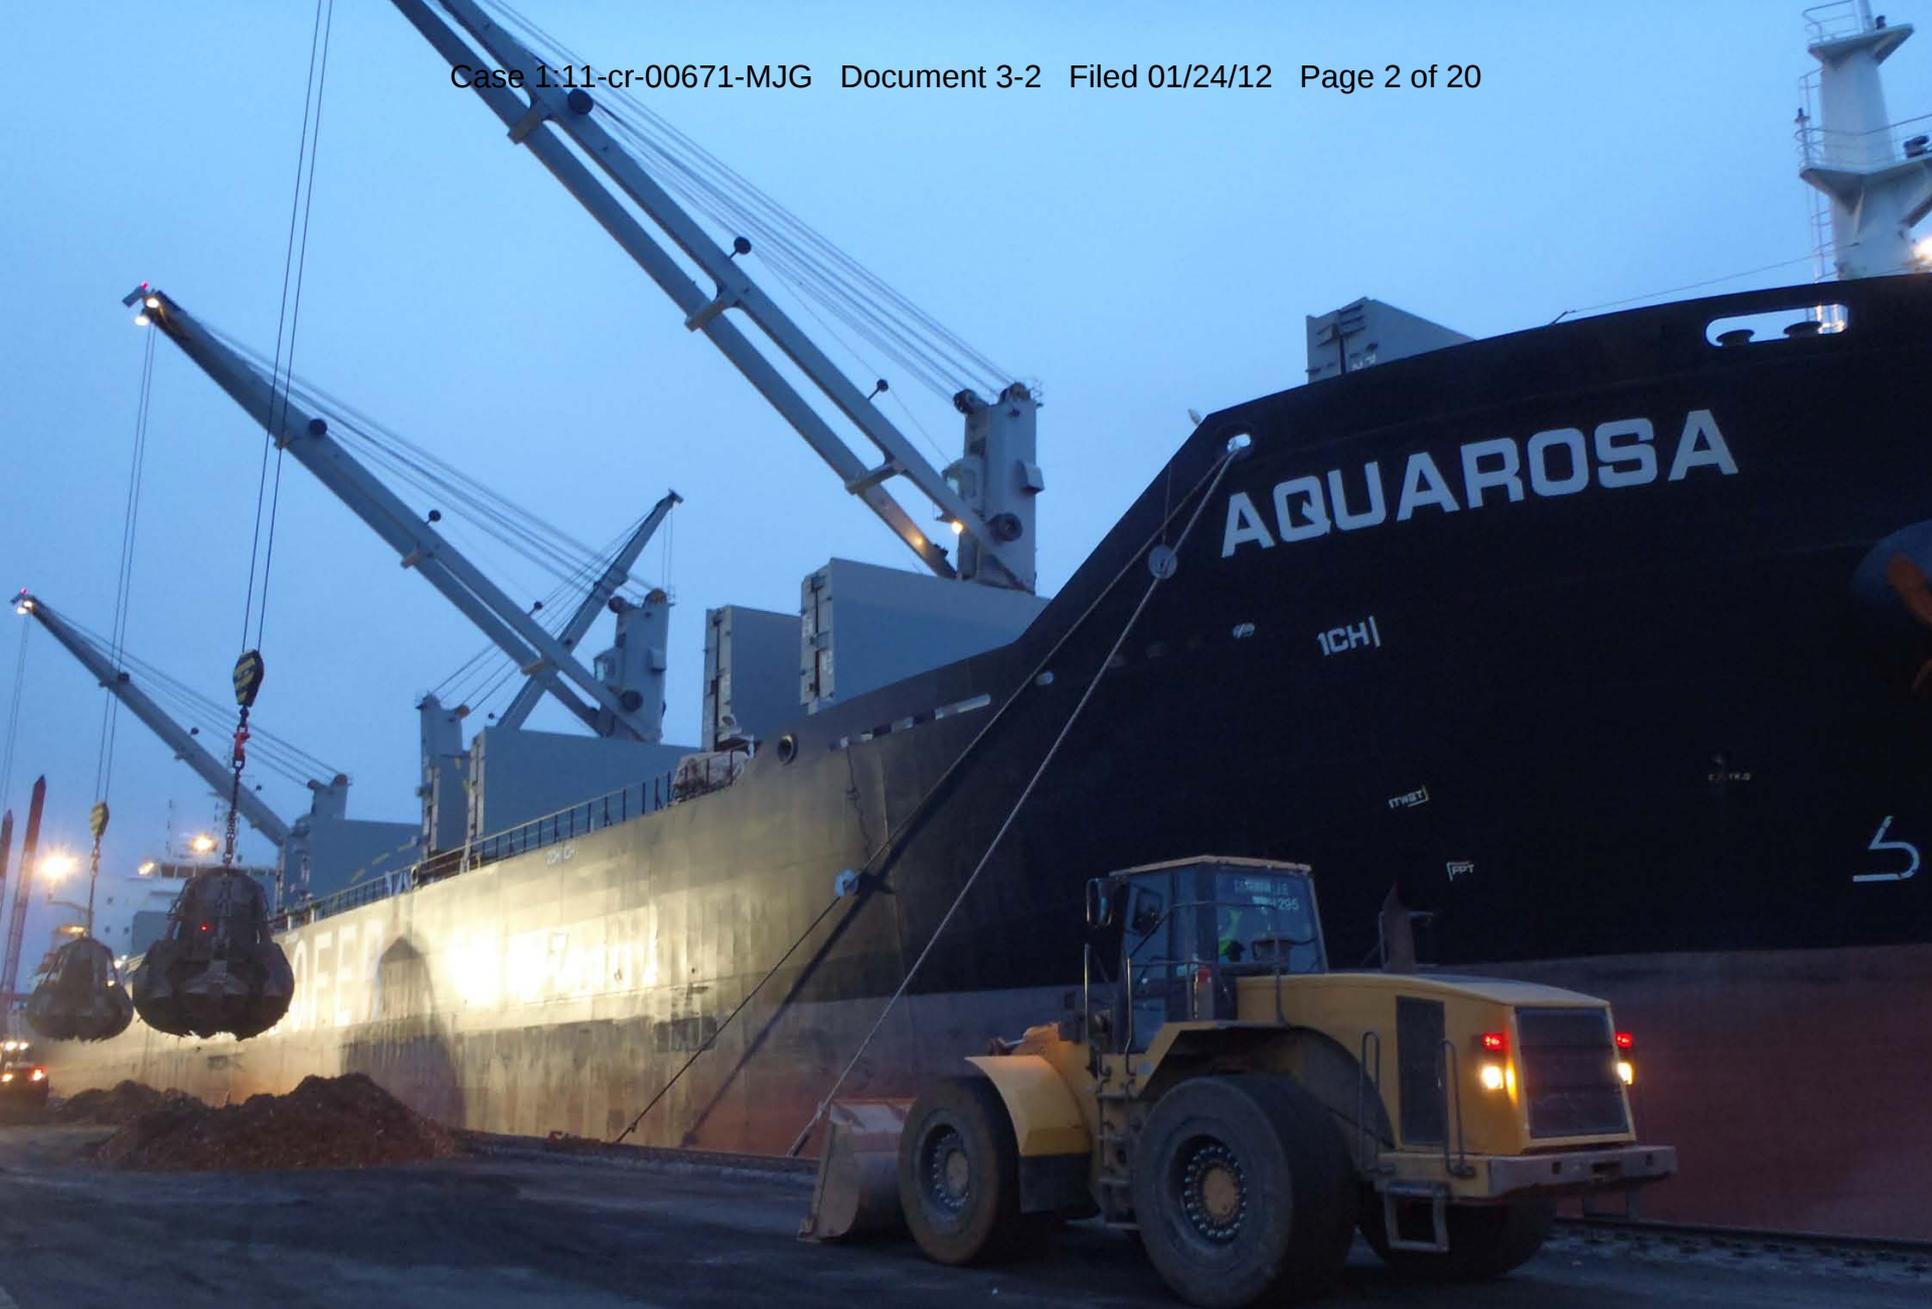
Exhibit 1

1. USCG photograph of M/V Aquarosa in Baltimore.
2. USCG photograph of M/V Aquarosa in Baltimore
3. Photograph of check valve external and internal blocking mechanism.

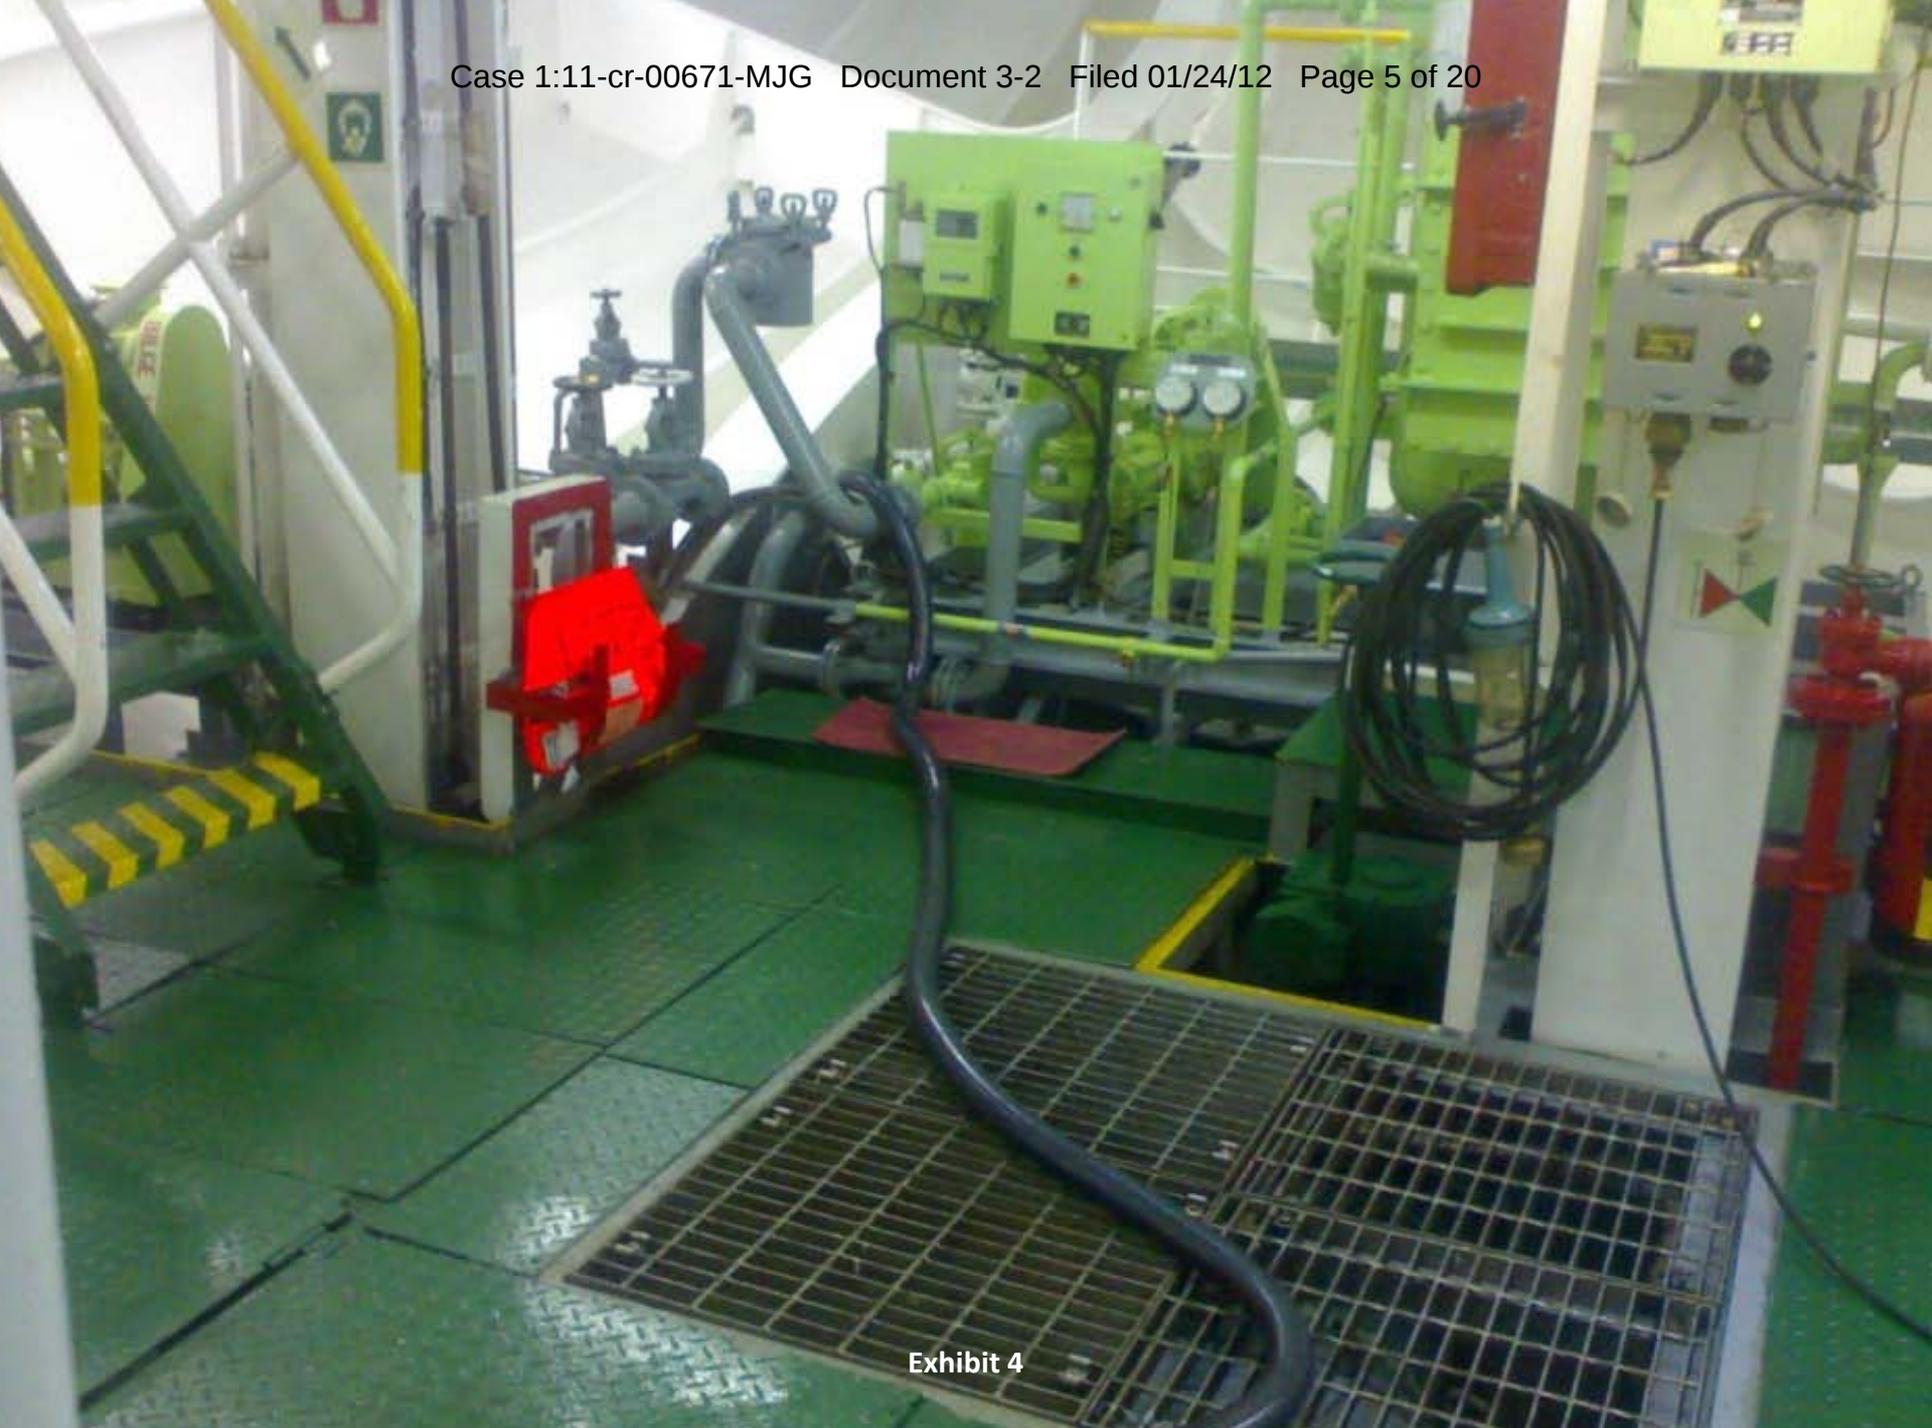
Exhibit 4

4. Whistleblower photograph taken at sea of bypass connected to overboard piping.
5. Whistleblower photograph taken at sea of bypass connected from sludge pump.

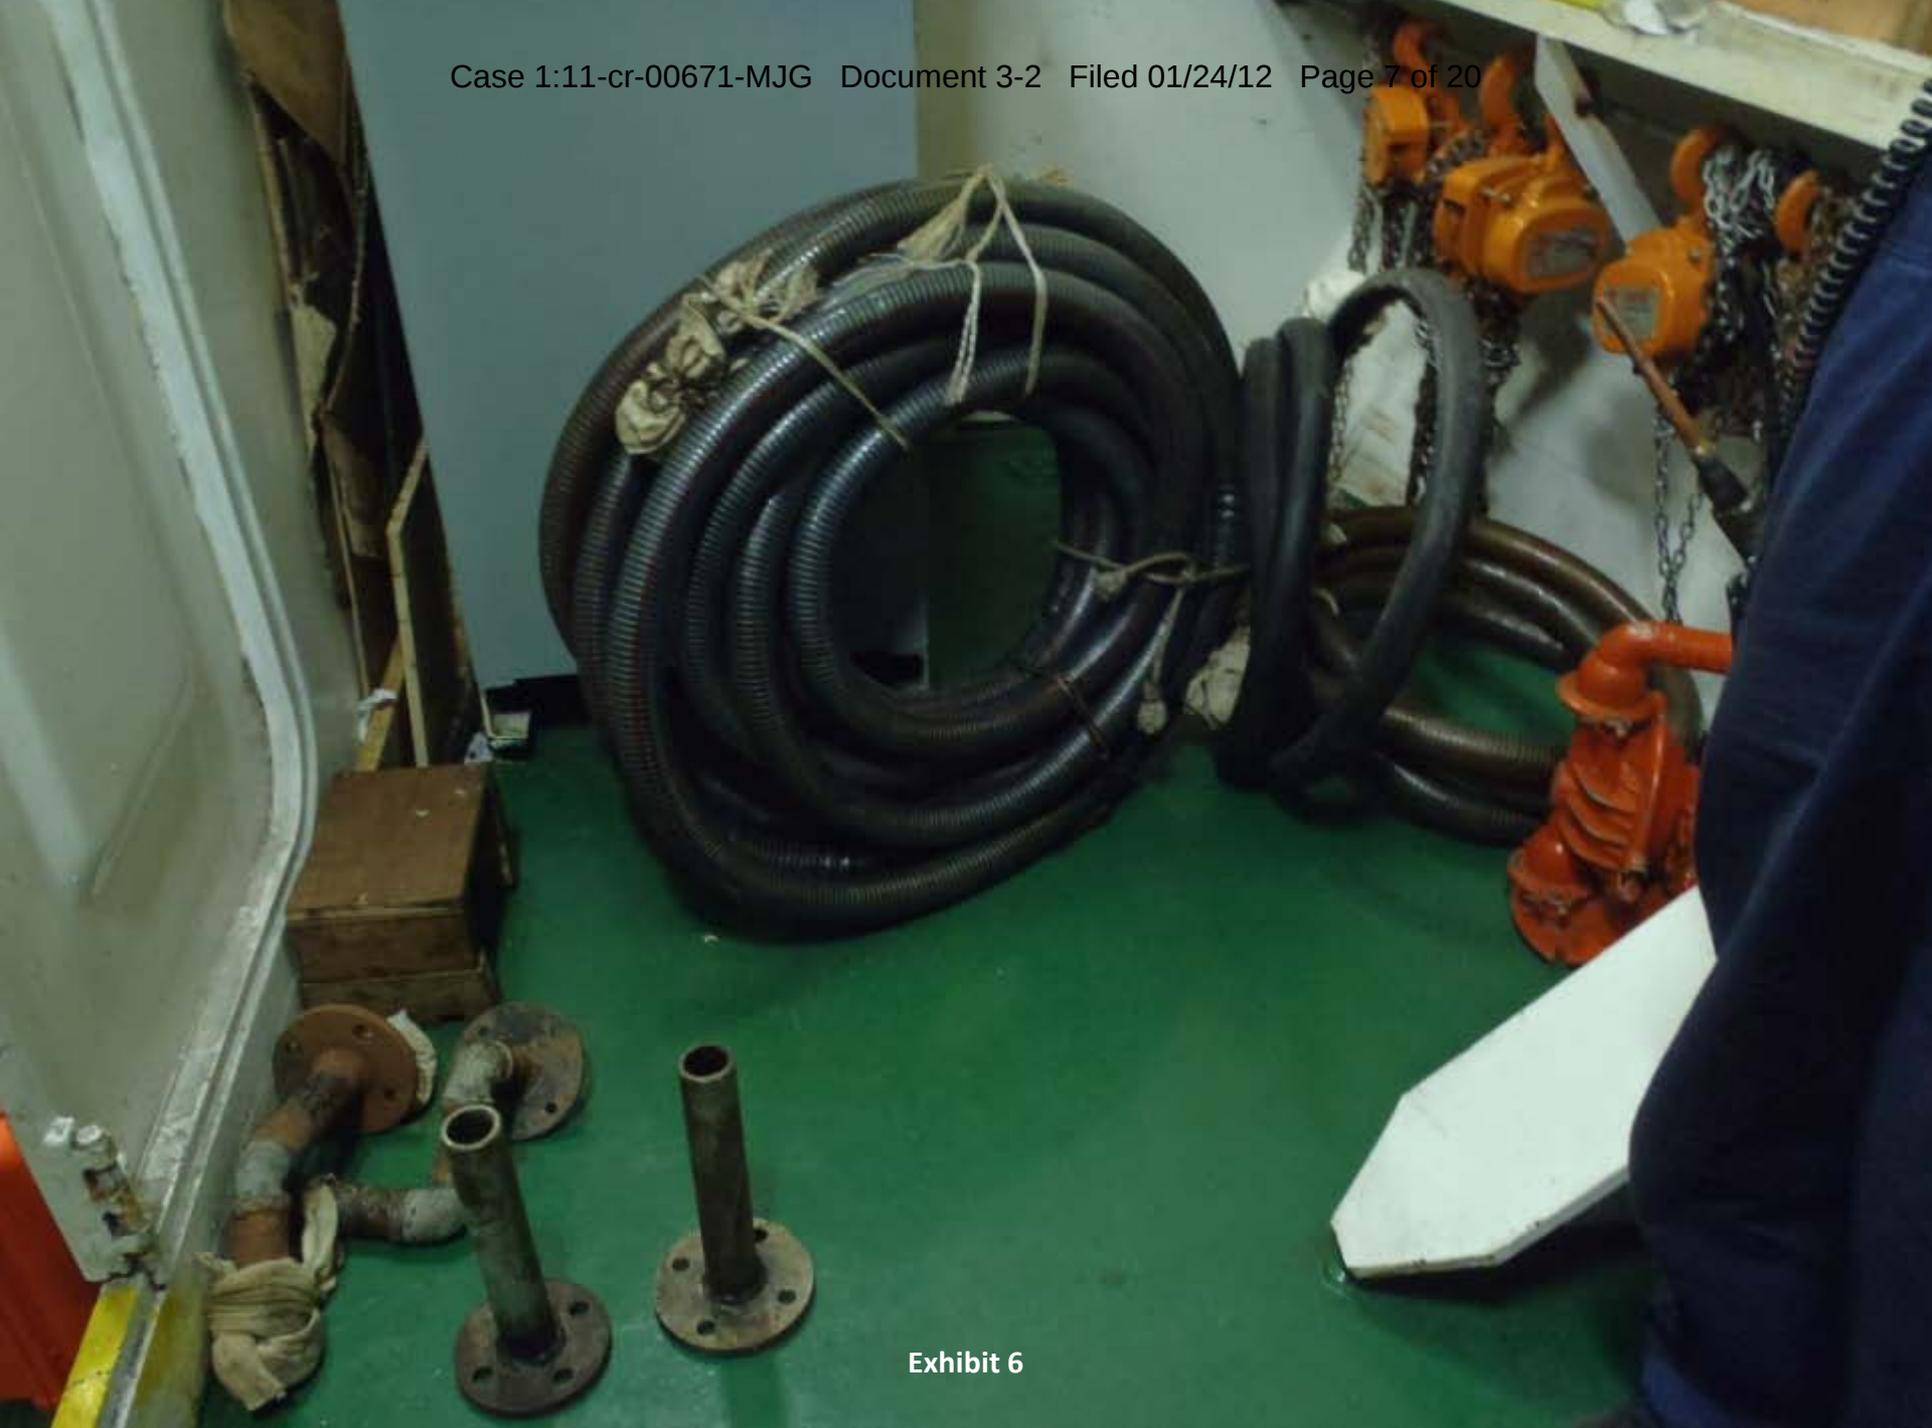
Exhibit 6

6. USCG photograph of bypass flanges and hose discovered during inspection in Baltimore.
7. USCG photograph of bypass flange discovered during inspection in Baltimore.

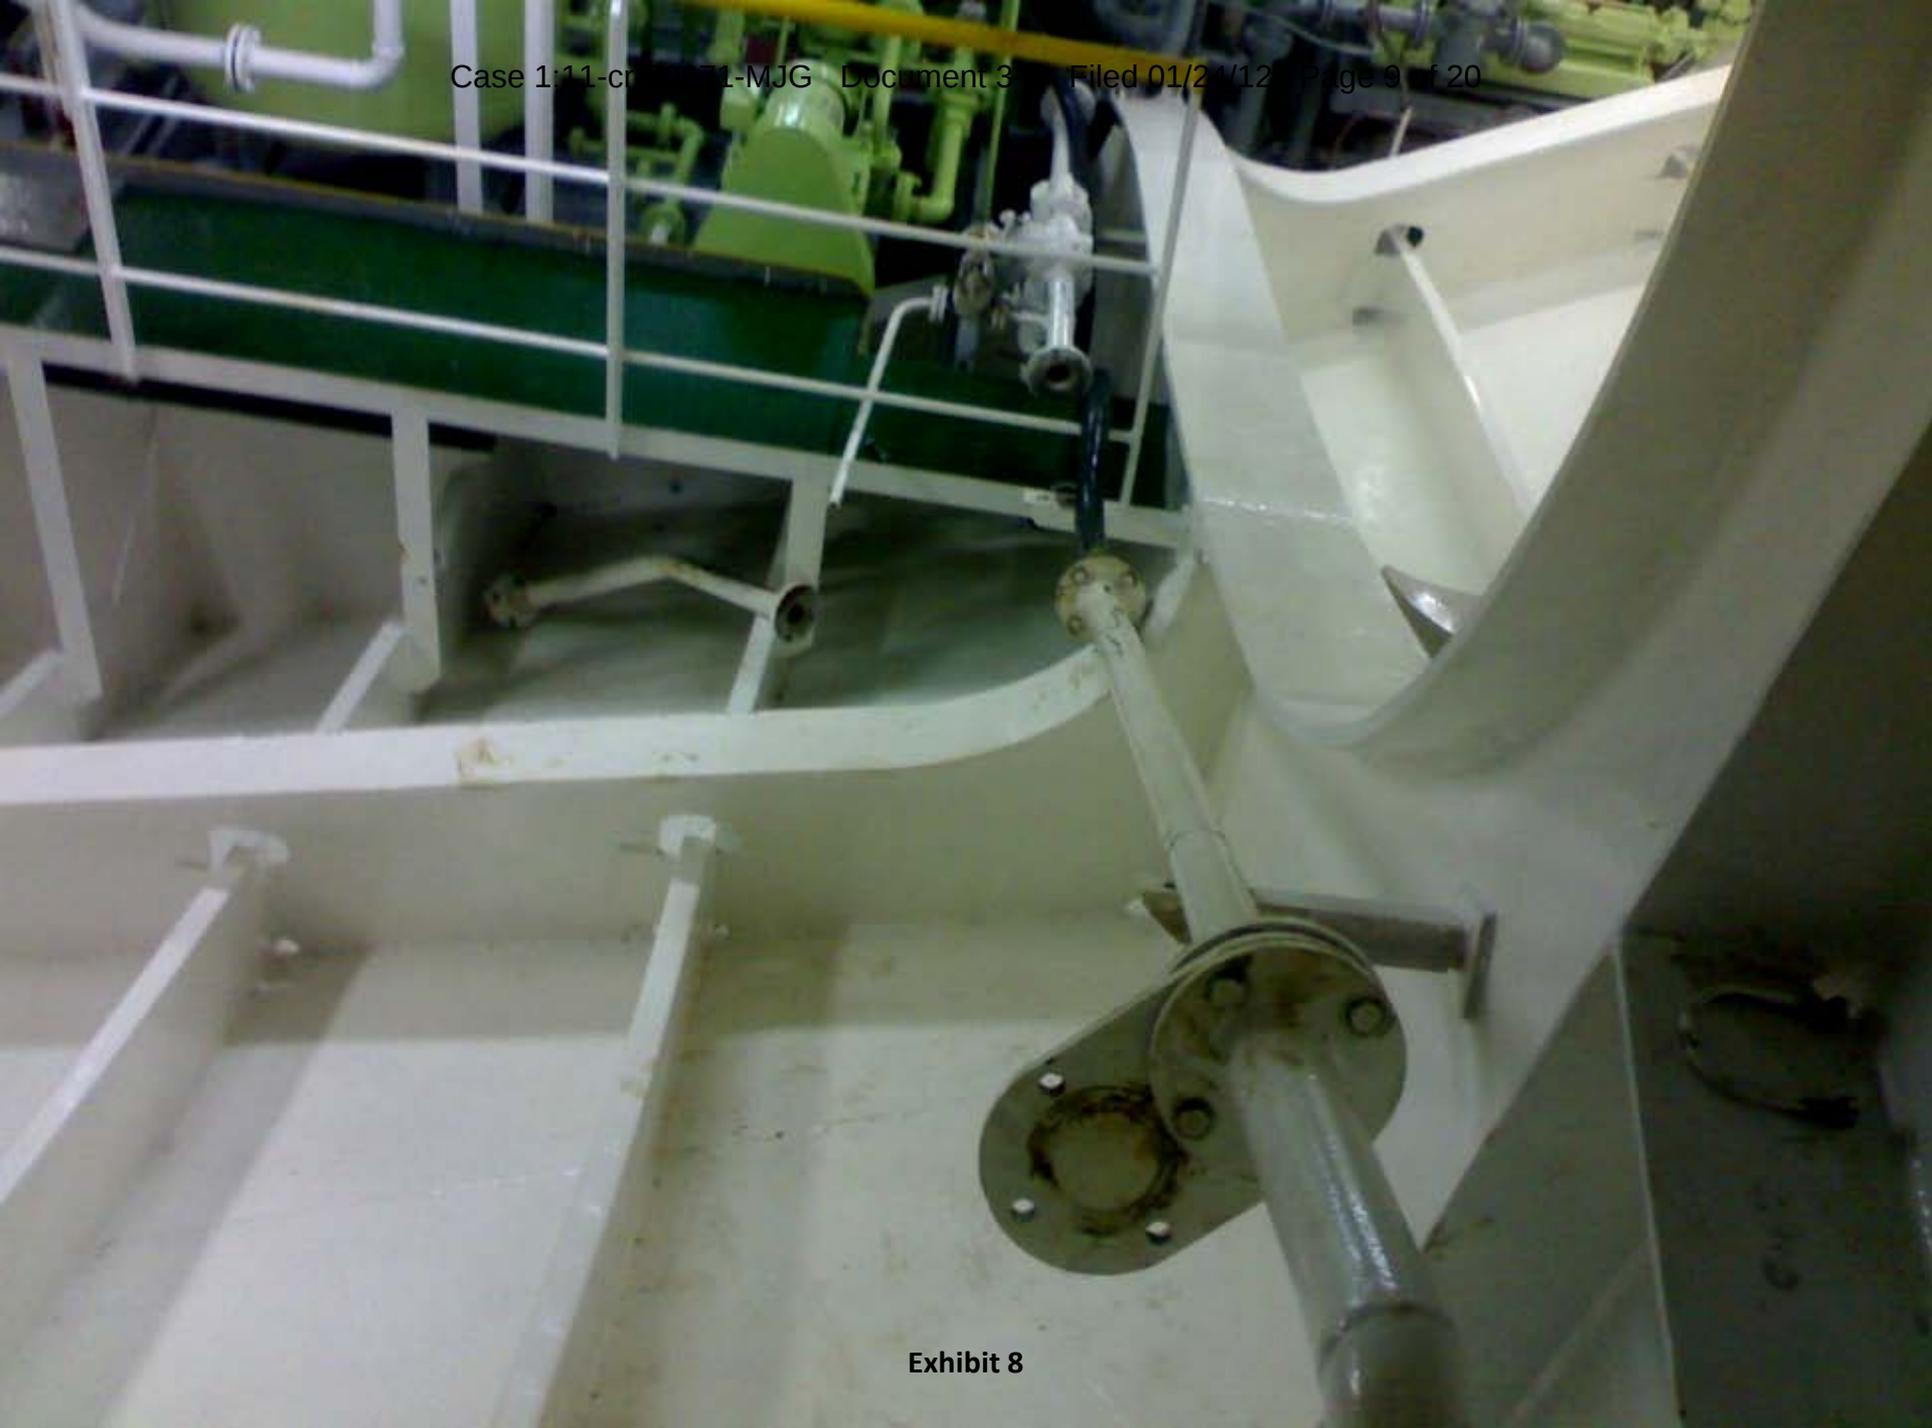
Exhibit 8

- 8-11. Whistleblower photographs taken at sea of bypass connected to overboard piping.
12. USCG photograph showing condition of M/V Aquarosa overboard piping in Baltimore without bypass.

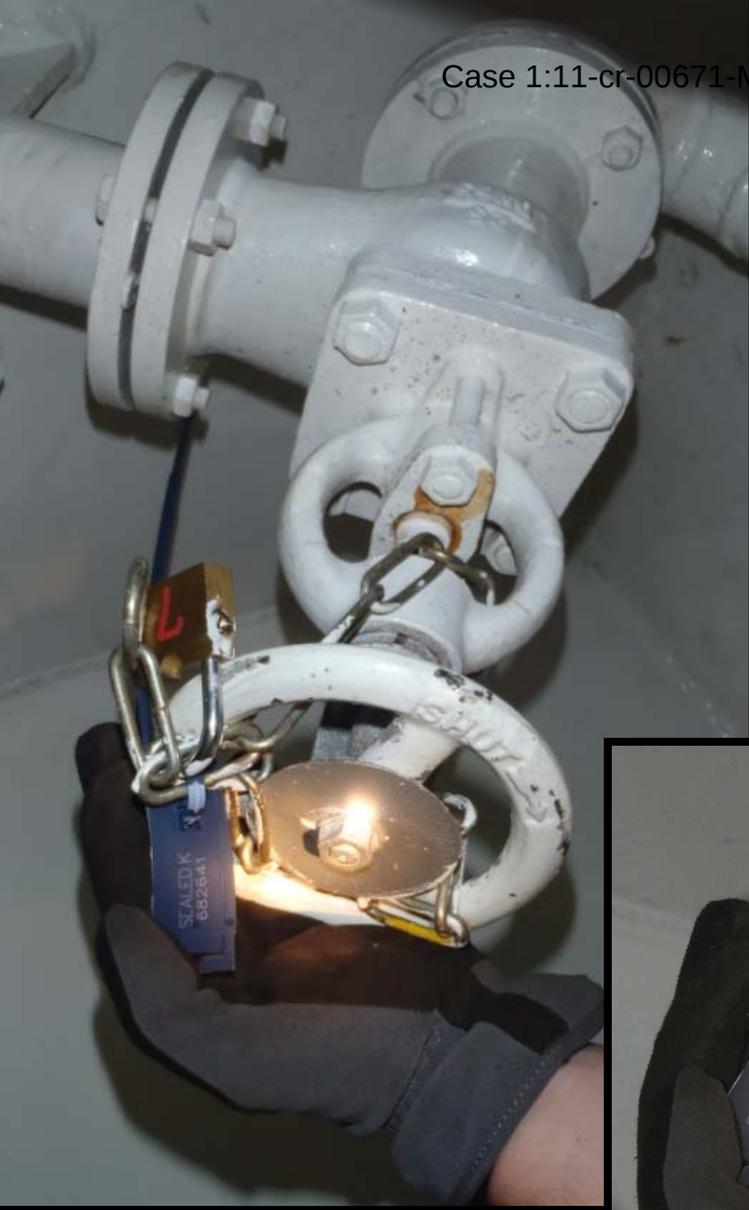
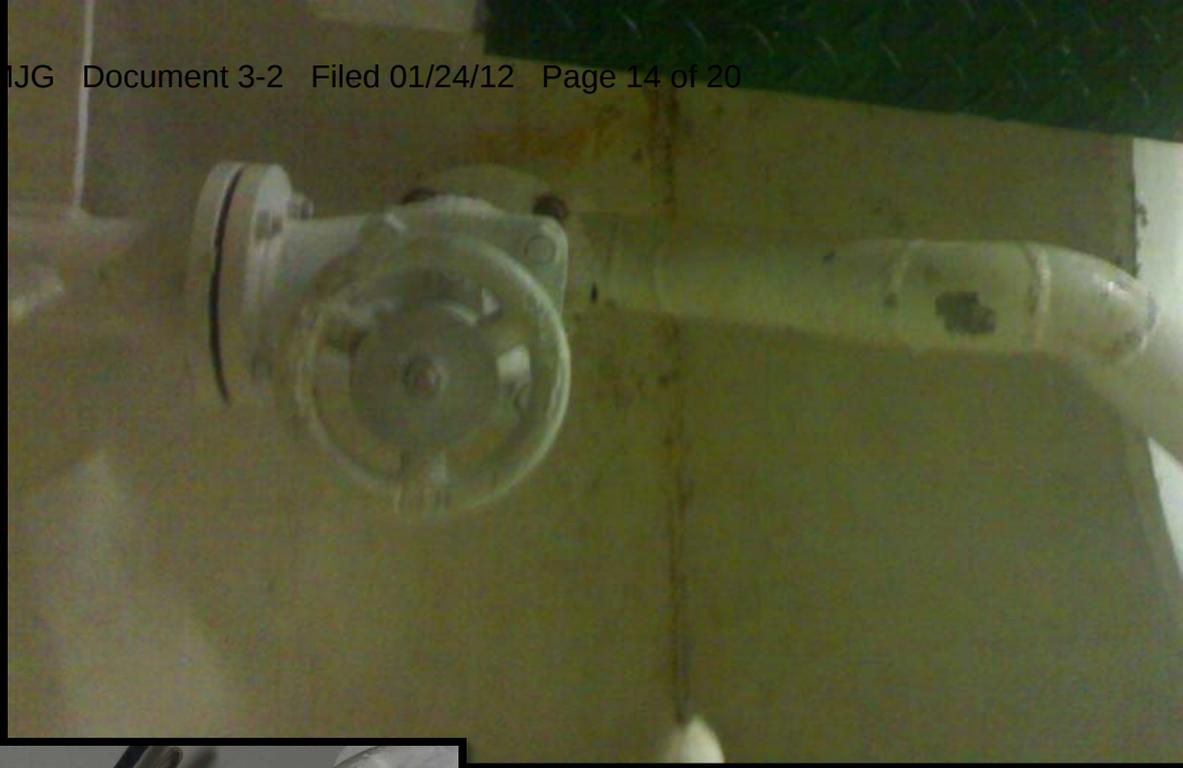
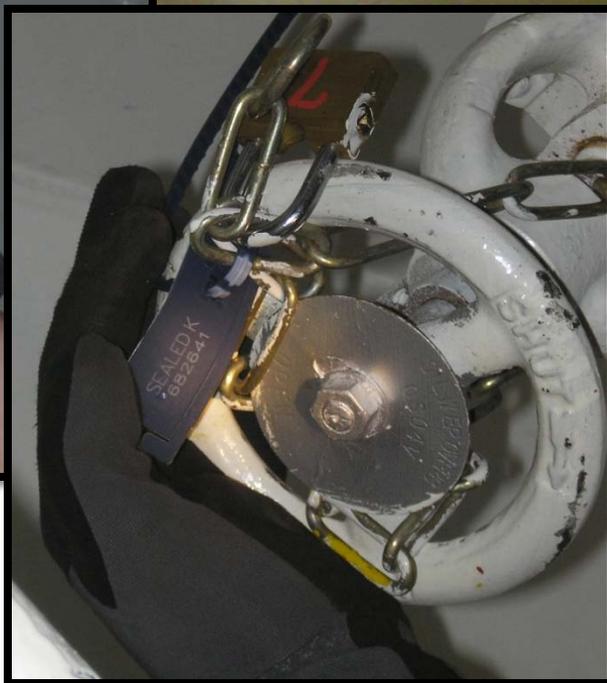
13. USCG photographs (left/center) showing locked overboard valve in Baltimore; and Whistleblower photograph taken at sea of overboard valve.
14. Whistleblower photograph taken at sea of bypass connected to boiler blowdown overboard valve.

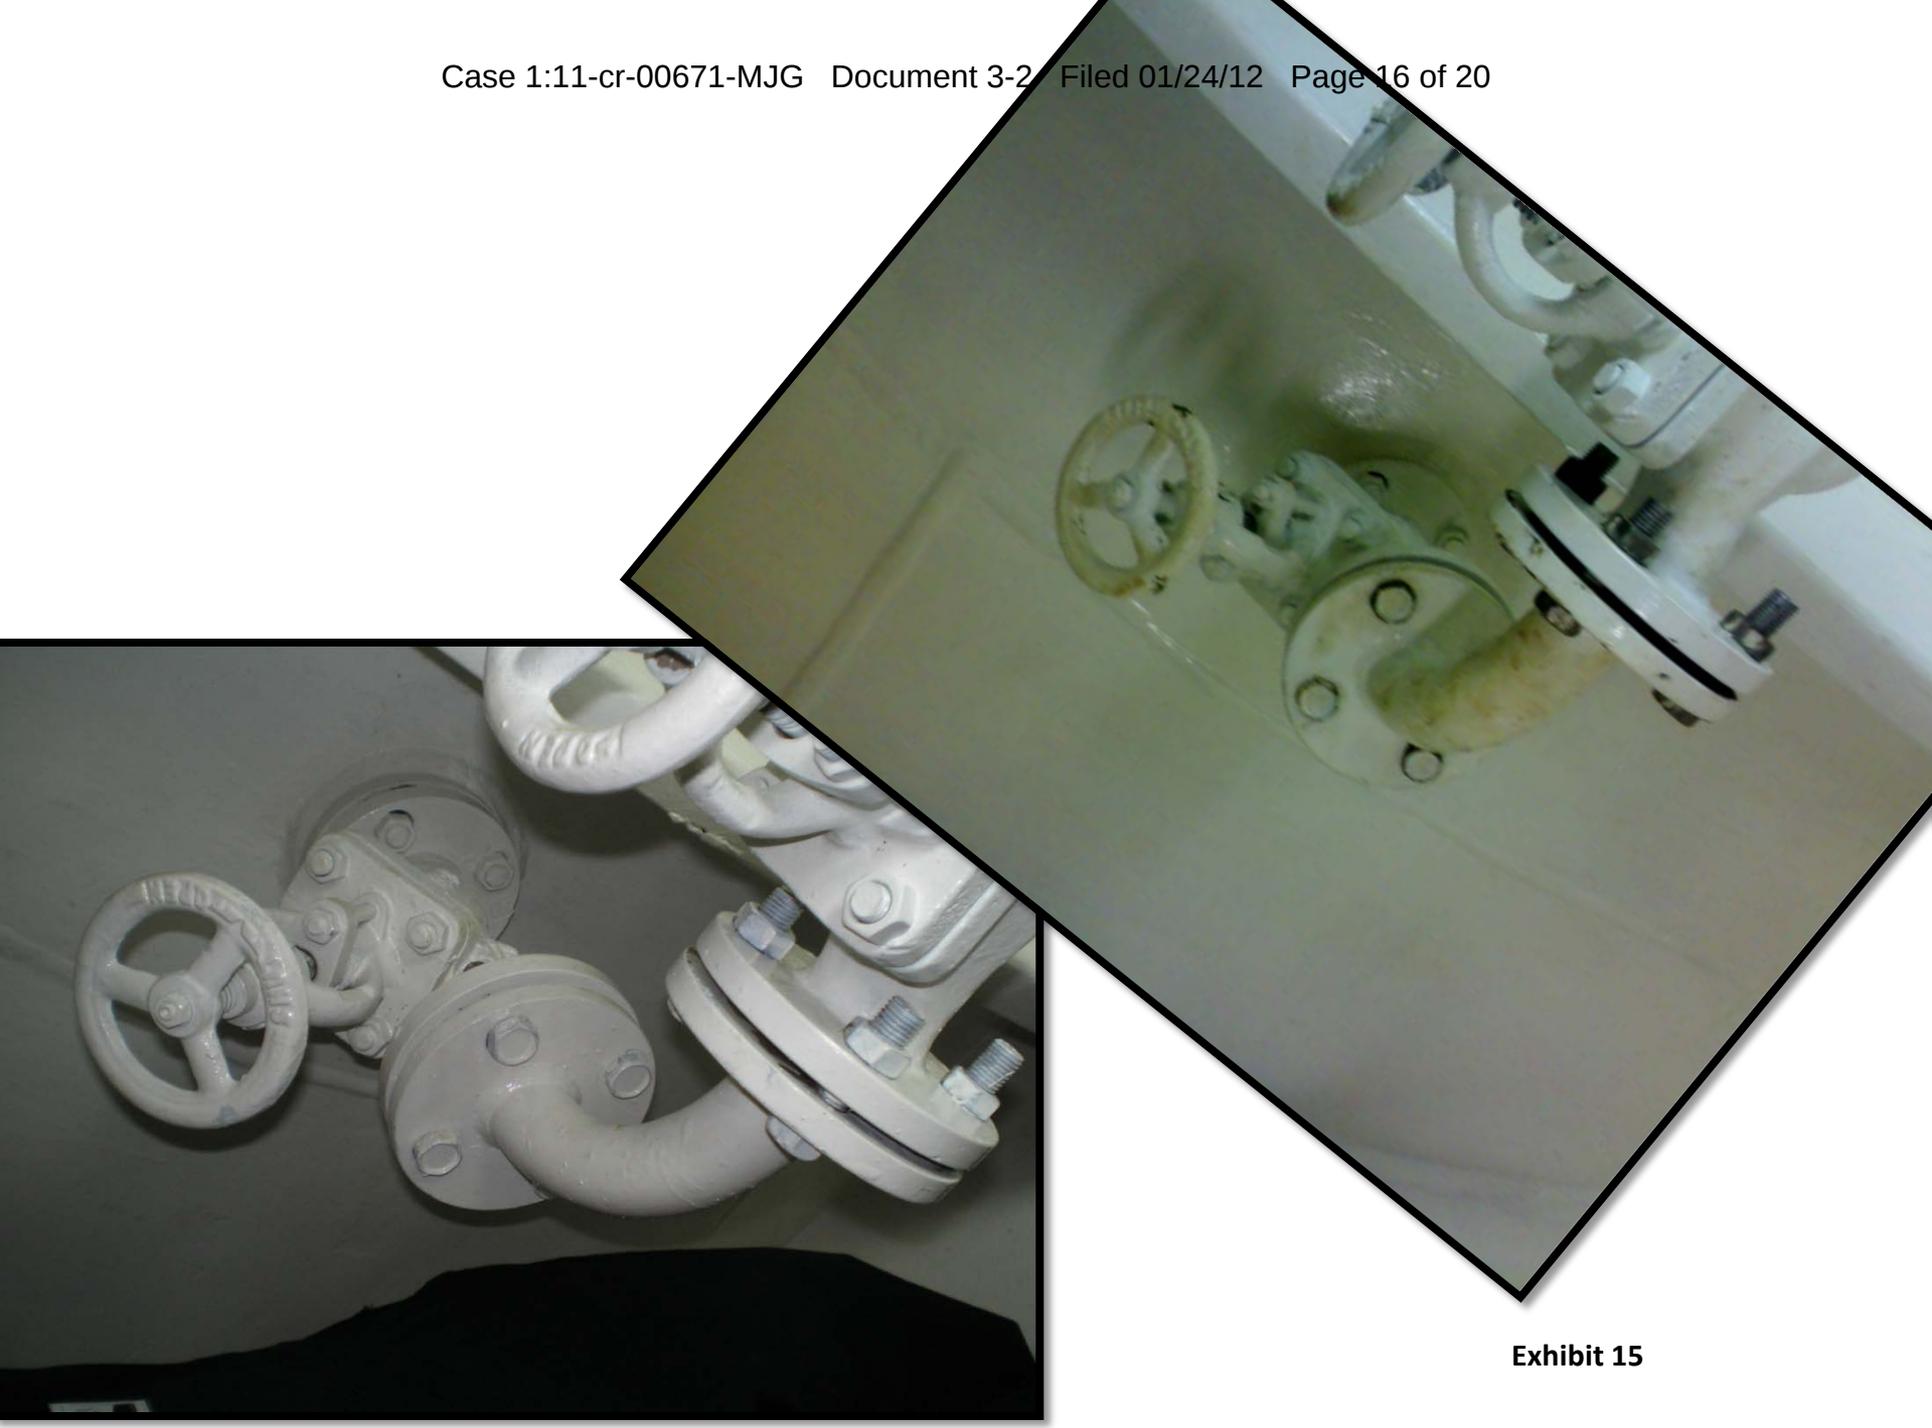
Exhibit 15

15. USCG photograph showing boiler blowdown overboard valve during inspection in Baltimore (left); and Whistleblower photograph of boiler blowdown overboard valve taken at sea (right).

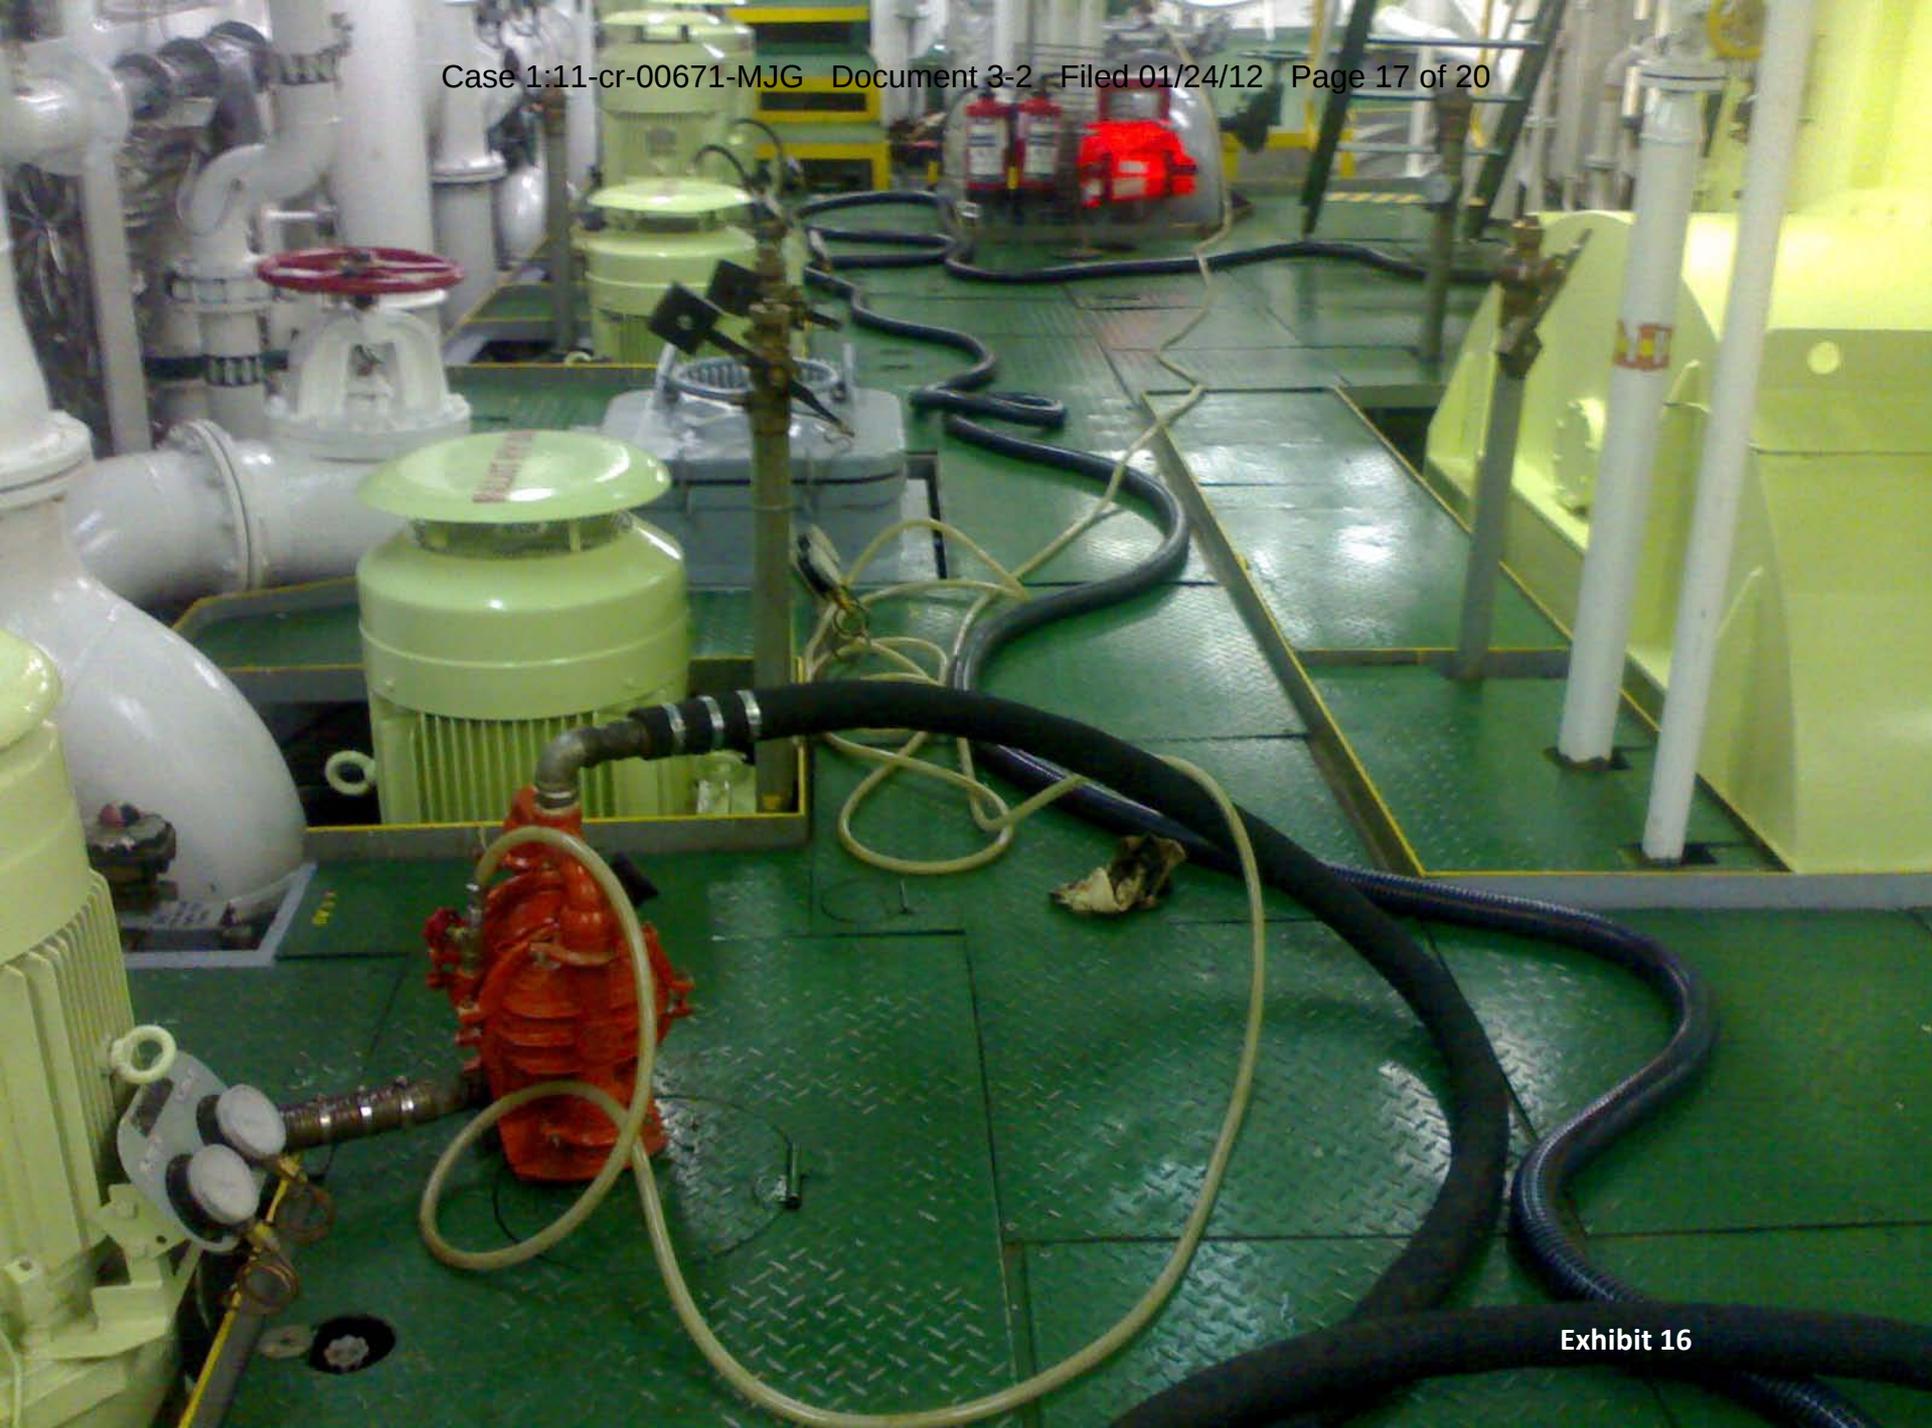
16. Whistleblower photograph of portable air pump (Weldon pump) being used for internal transfers of waste oil.
17. Whistleblower photograph taken at sea of calendar and sounding log showing drop in tank volume.

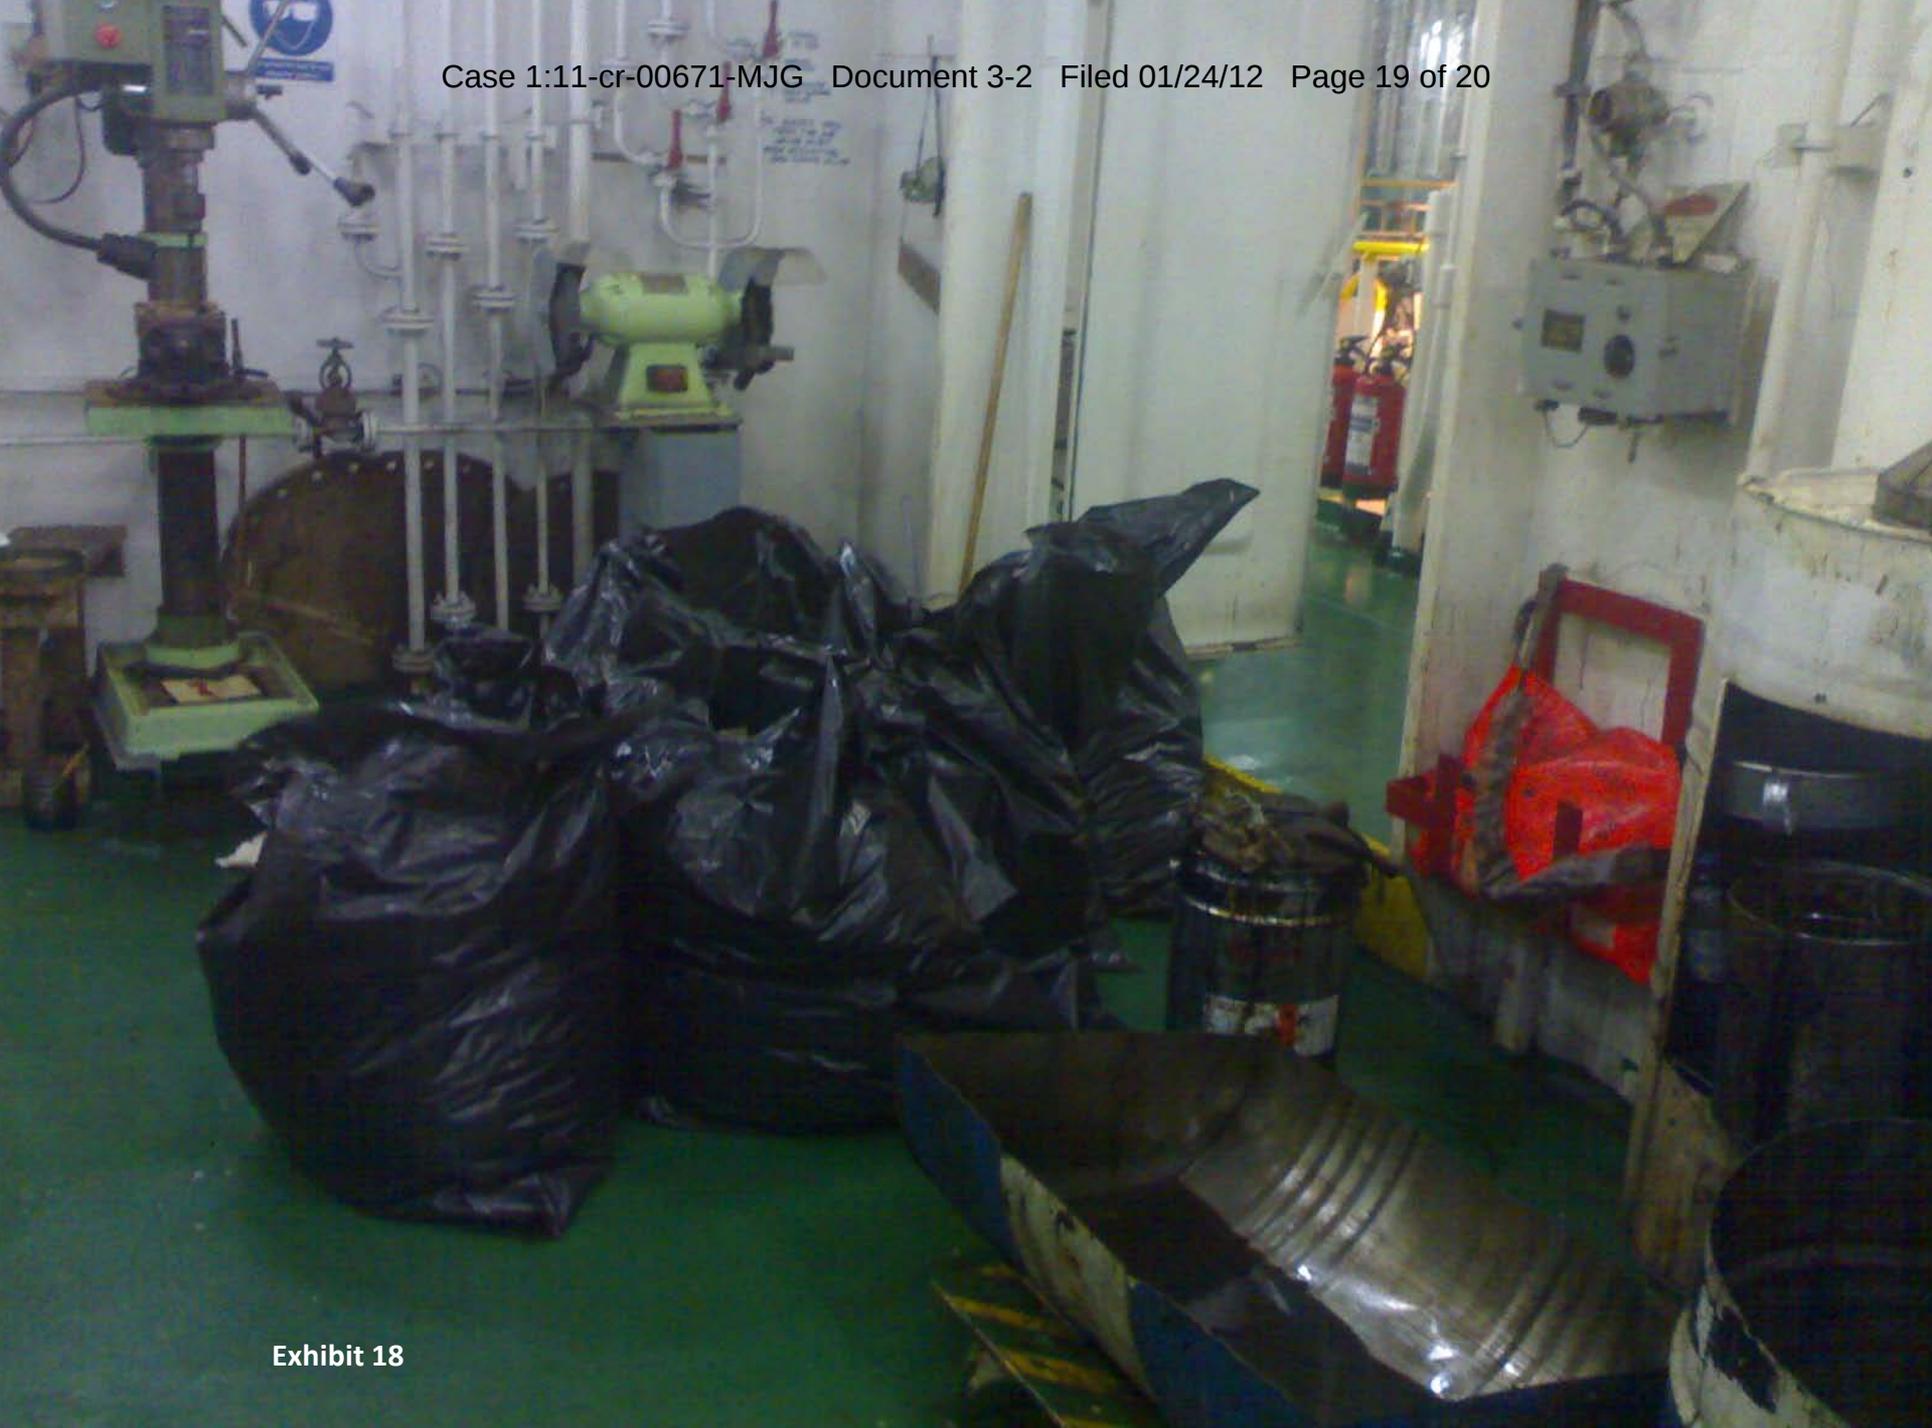
Exhibit 18

18. Whistleblower photograph taken at sea showing accumulation of oily rags in plastic bags.
19. Whistleblower photograph taken at sea showing oily rags in plastic bags on ship's deck.
