UNITED STATES DISTRICT COURT
DISTRICT OF MARYLAND

UNITED STATES OF AMERICA v. EFPLOIA SHIPPING CO., S.A.

UNITED STATES OF AMERICA v. AQUAROSA SHIPPING, A/S

Attachment B
GOVERNMENT'S
MOTION FOR WHISTLEBLOWER AWARD

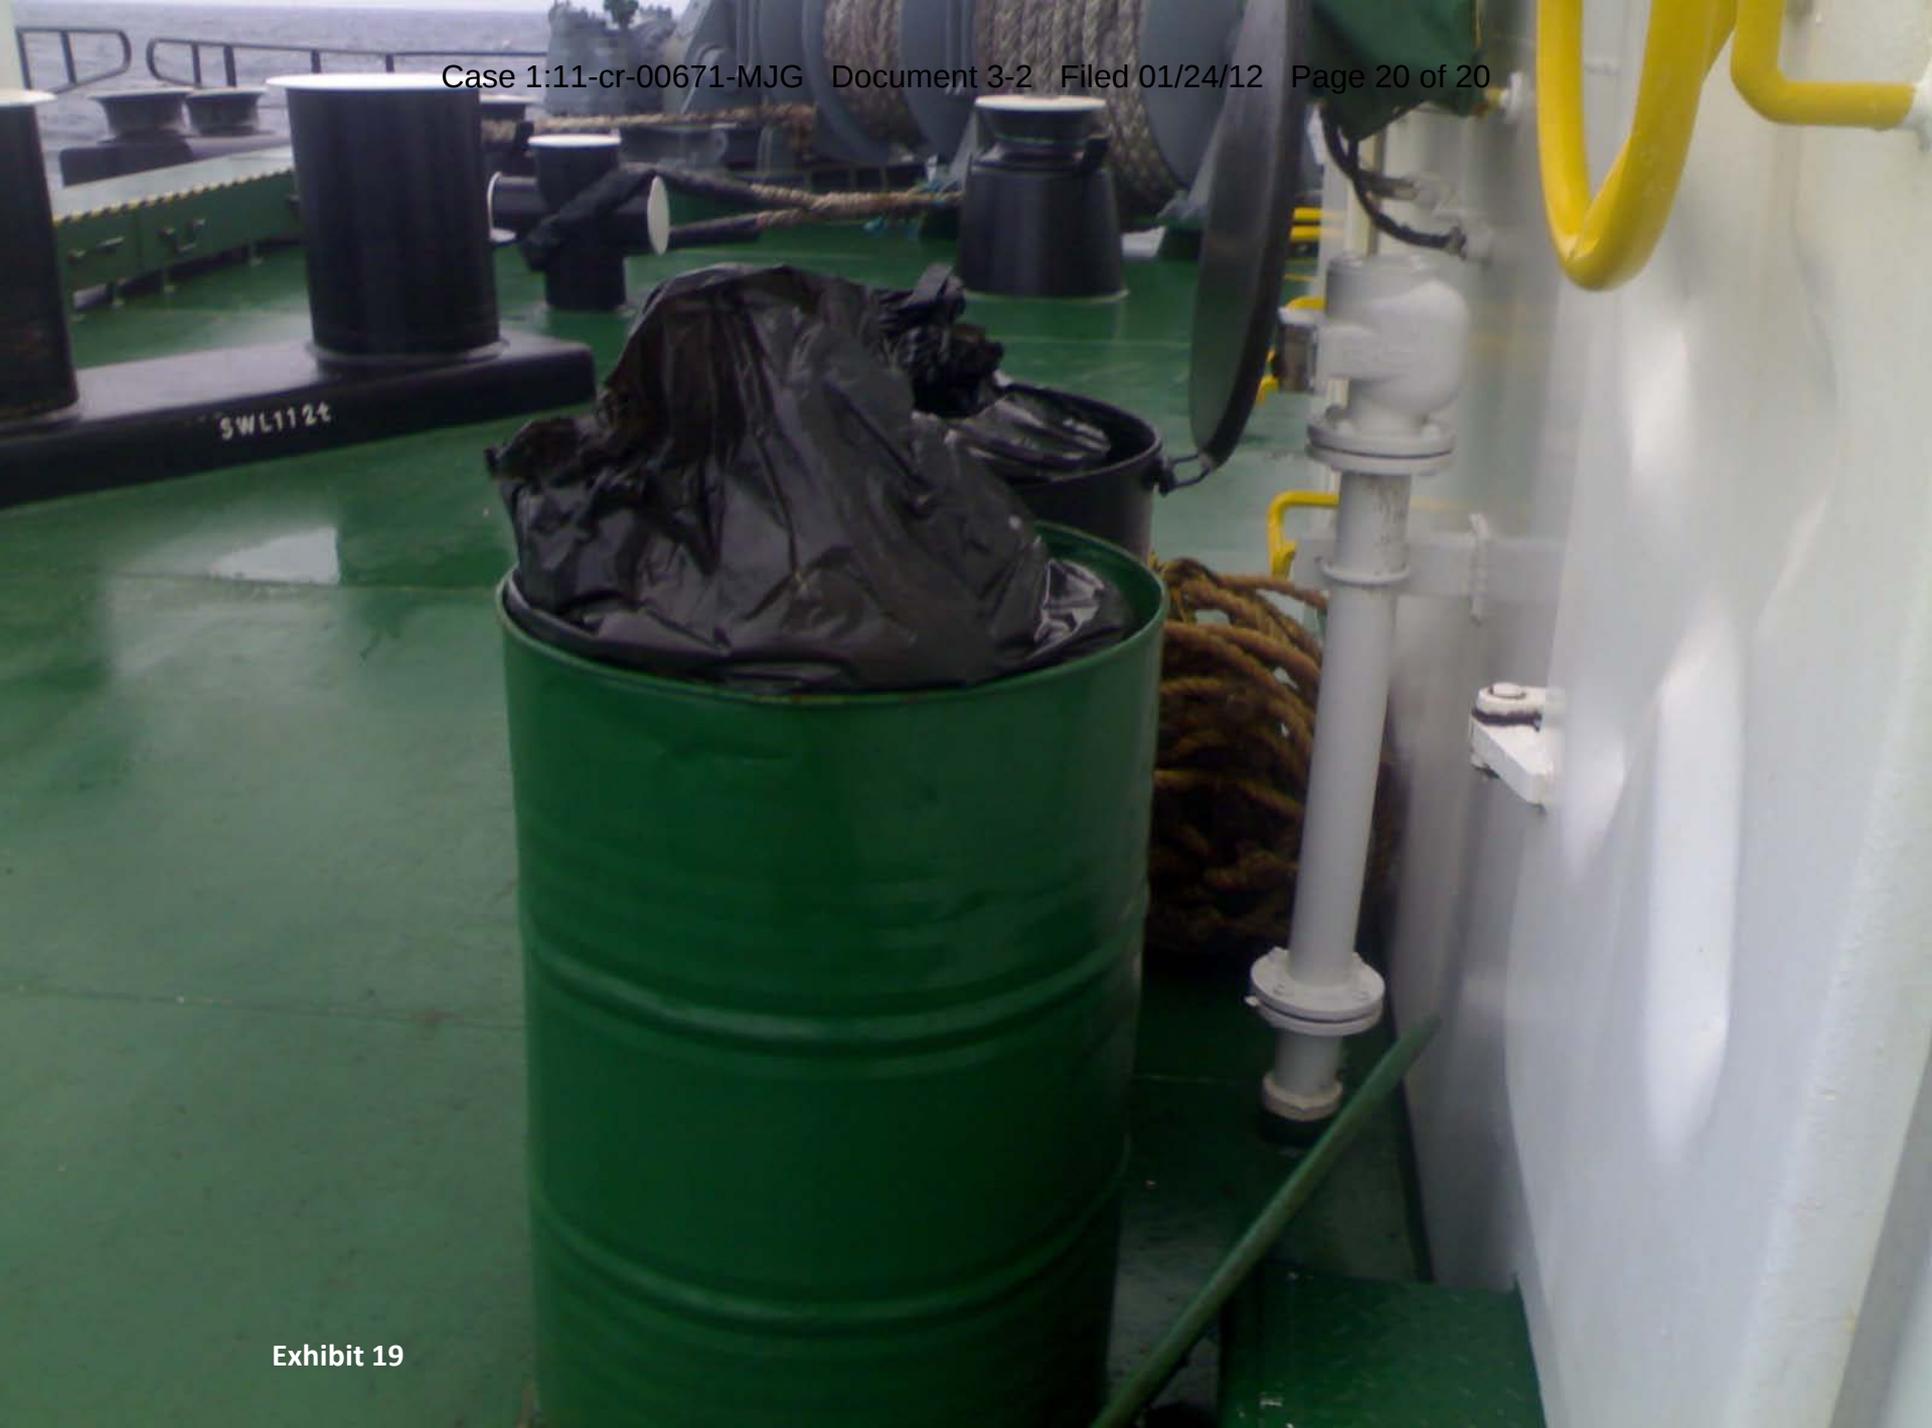
Exhibit 19

18. Whistleblower photograph taken at sea showing accumulation of oily rags in plastic bags.
19. Whistleblower photograph taken at sea showing oily rags in plastic bags on ship's deck.
