<u>United States v. Princess Cruises, Ltd.</u>

Government's Exhibits in Support of the Joint Factual Statement

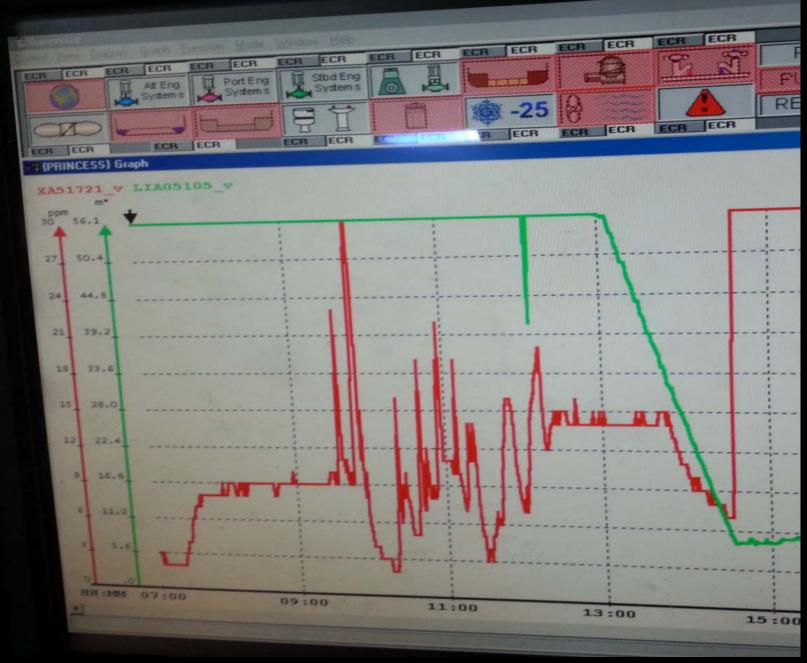
Graph from Caribbean Princess Engine Control Room

- 1. Map of Caribbean Princess voyage August 26-27, 2013.
- 2. Display of Caribbean Princess engine room computer on 08.26.13 showing a discharge in excess of the capacity of the OWS.

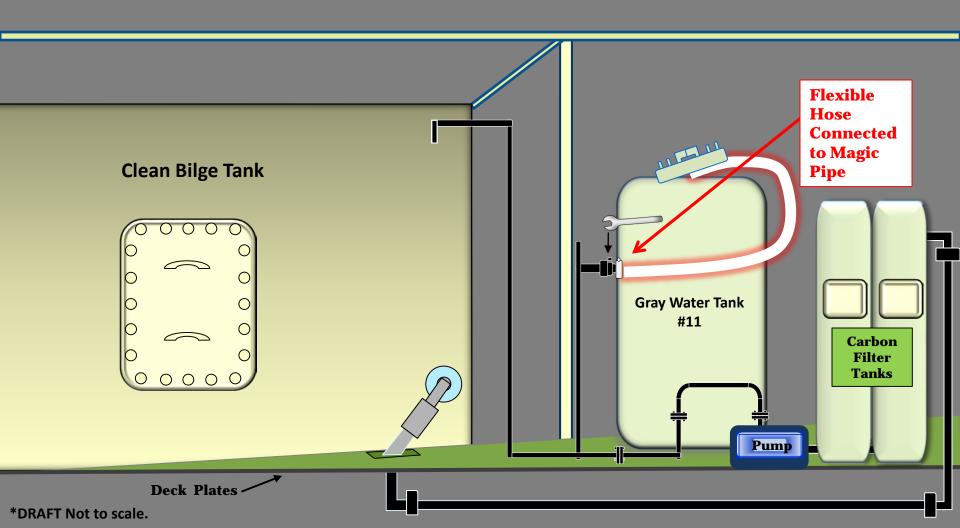
Caribbean Princess Bypass Method Used in 2013

- 3. Sounding sheets for 08-26-13 by four different crew members documenting the drop of Oilers showing drop in the Clean Bilge Tank.
- 4. Government diagram of the standing pipe method of bypassing used in 2013.
